CLASSIFICATION		SECRET			25X 25X
COUNTRY	Czechoslovakia		REPORT NO.		
TOPIC	1. Pillbox Construction in Ruzomberok.				
	2. Security Detachments on the Zilina - Ruzomberok Railroad Line.				
25X1X EVALUATION		PLACE OBTAINED		25X1C	
25X1C DATE OF CONTENT					
DATE OBTAINED		DATE PREPARED	14 December 1953		
25X1A REFERENCES					
PAGES	3 ENCLOSURES (NO. & TYPE)				
REMARKS					
25X1X

Location Sketch of the Concrete Pillbox in Ruzomberok

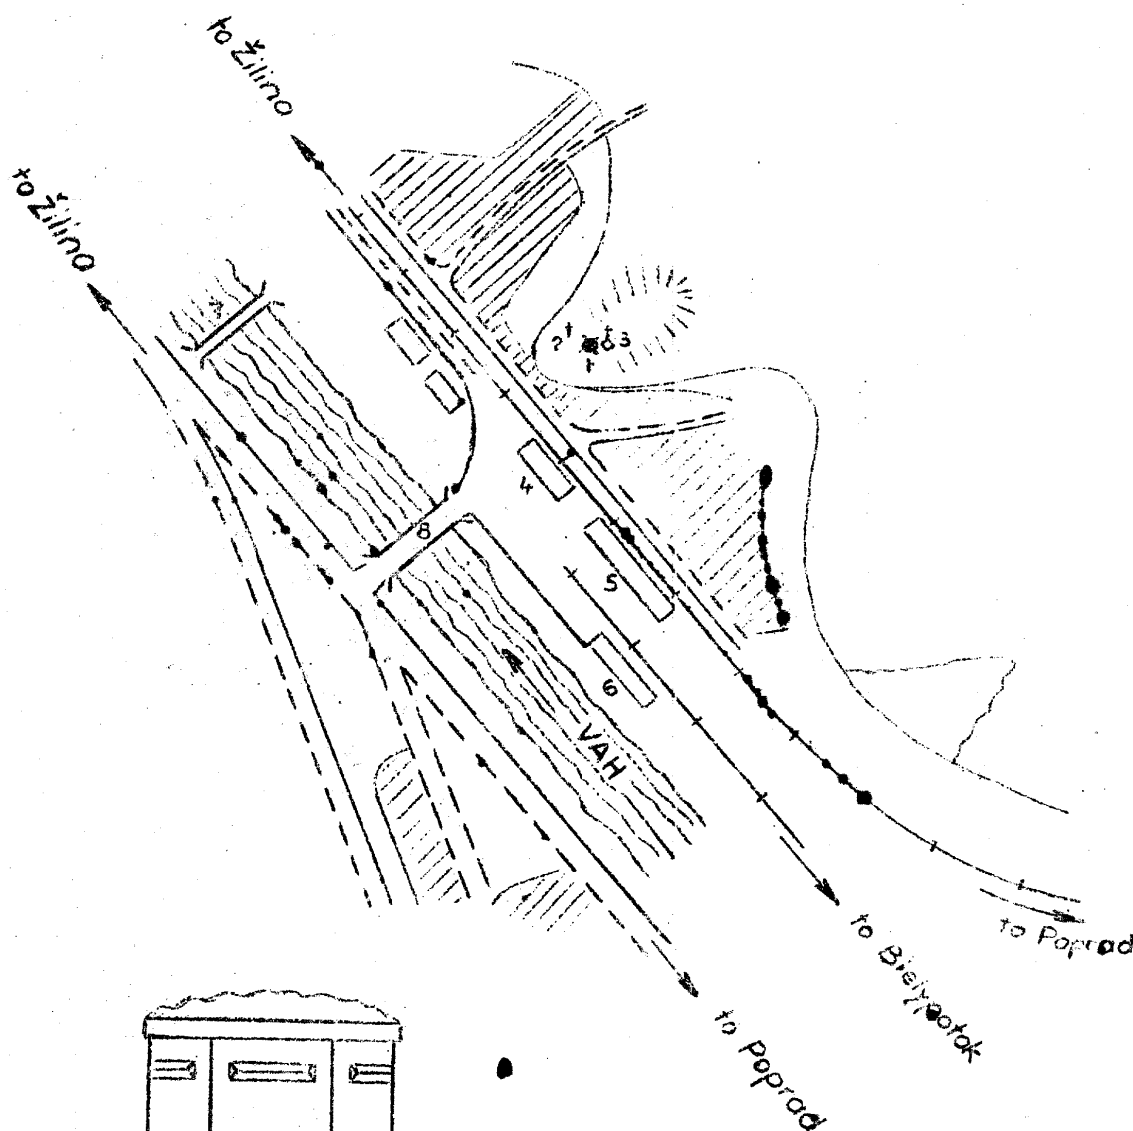
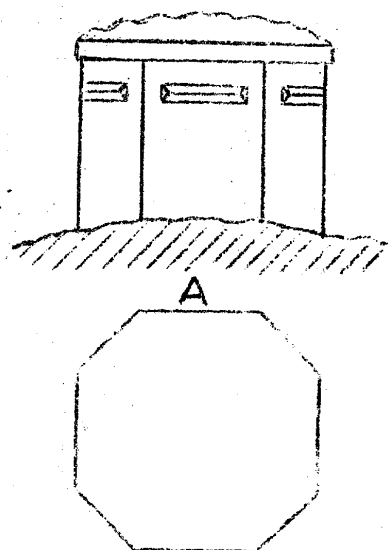
Location Sketch of the Concrete Pillbox in Ruzomberok.

- On 10 October 1953, an octagonal concrete pillbox was under construction on the Cavalry Hill northwest of the Ruzomberok (Q 50/C 99) railroad station close to the chapel. The hill commanded the town area of Ruzomberok, the railroad station, the bridges over the Vah River and a fairly long section of the Zilina (Q 50/O 92) - Kosice (R 49/E 34) double-track railroad line. The pillbox, which was worked on by two construction workers, projected about 1.5 meters from the ground and had a flat roof covered with an earth layer. Each of the visible side walls had a loophole, about 70 cm wide and about 25 cm high, which was about 30 cm beneath the roof.

- 1 Pillbox
  - 2 Cross
  - 3 Chapel
  - 4 Railroad Station
  - 5 Railroad depot
  - 6 Railroad depot
  - 7 Wooden bridge - closed
  - 8 Wooden bridge
- A Projection and horizontal plan of pillbox.
